Correct Installation of the solenoid valve – all air conditioning systems

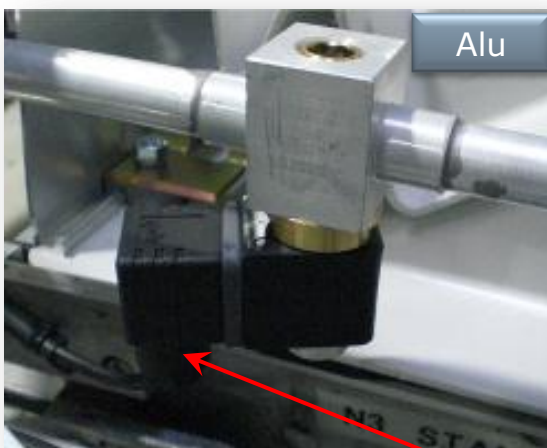
Aluminum system

As part of product quality monitoring and analysis, we see an increased amount of solenoid valves **1102620A** which have been sent back with warranty claims asserted because of internal corrosion damage. These damages point to an incorrect positioning of the solenoid valves.

The electrical connection must **always facing down** to prevent an ingress of moisture through it.

Against this background we would like to point out, that the installation of a new solenoid valve must be done mandatory according to the shown schema.

IMPORTANT
The cable outlet must **always facing down.**
